Subj: BRANCH MEDICAL/DENTAL CLINIC, QUANTICO POE REPORT

POST OCCUPANCY EVALUATION REPORT

BRANCH MEDICAL/DENTAL CLINIC QUANTICO, VIRGINIA

PREPARED BY: NAVFACHQ MEDICAL FACILITIES DESIGN OFFICE

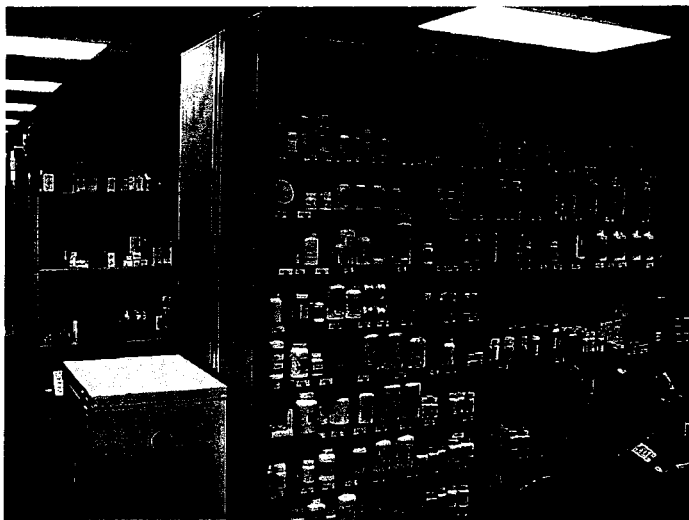
Picture 7

1. Incorporate a combined instrument center manufacturer: Welch Allyn (see photo).
OCC HLTH/PREV MED, Exam Room 2F05 - Green Team
2. Baker cells are not durable. *Pharmacy - Green Team*
3. Storage shelves appear to be too high; less than 18" from ACT/fire sprinkler head.
Pharmacy - Green Team

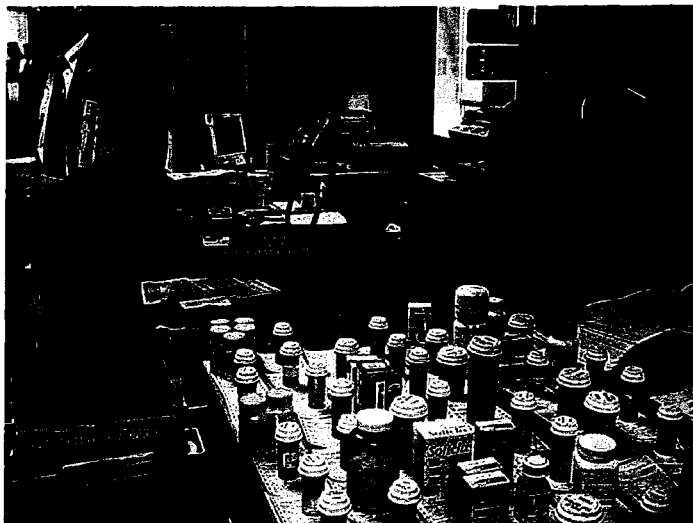
Picture 8

4. Anti-fatigue mats should be part of MCLO budget. *Pharmacy - Green Team*
5. Limited pill dispensary. *Pharmacy - Green Team*

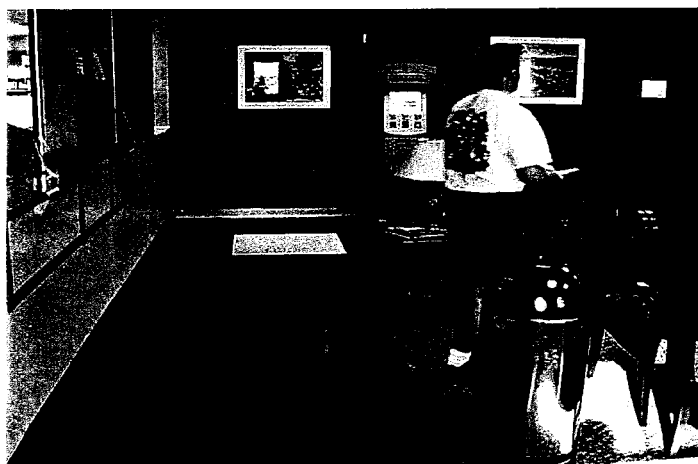
Picture 21

9. Location of recessed fire extinguisher appears to be inappropriate or counter is not appropriate. *Pharmacy - Green Team*
10. Department sort/branch of post office. One postal clerk; not secure enough if used as full service post office. *Command Suite, Mailroom - Green Team*
11. Patient privacy a problem at window. No ADA window. Junky appearance. Pharmacy pull down is manual (heavy), which is an ergonomic problem. Windows are not reset after fire drill. Good regular windowsill throughout facility. *Pharmacy - Green Team*

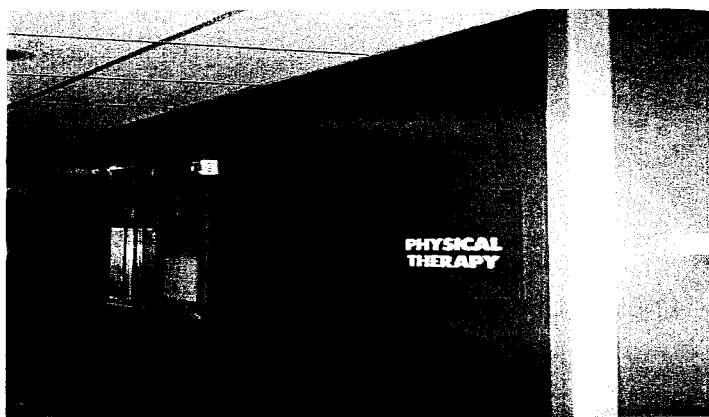
Picture 22

12. Patient bathrooms in clinic areas are very large and ADA accessible. All sinks require padding on traps for wheelchair clients' protection. All toilet tissue dispensers should be changed to allow more than three squares of tissue (customer satisfaction issue). *General, Toilets - Blue Team*
13. Need more counter space. *OCC HLTH/PREV MED, IH Lab - Green Team*
14. Techs put privacy screen on window. *Physical Therapy - Green Team*

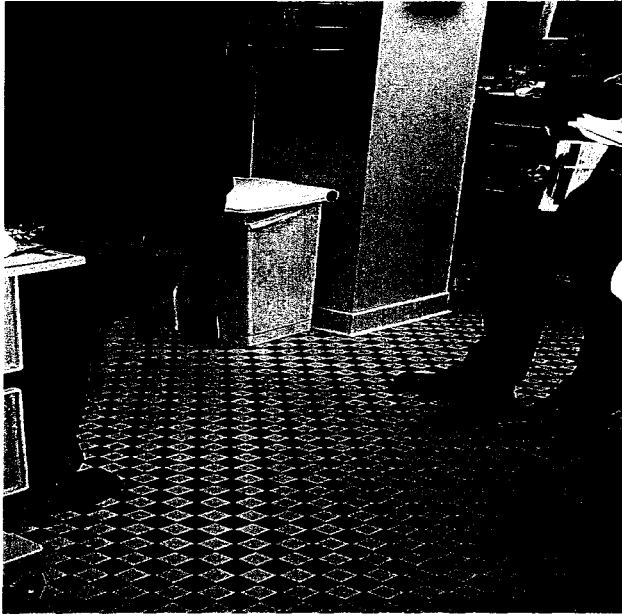
Picture 25

- 58. Curtain tracks (not necessary) *Mental Health, Social Worker Office - Green Team*
- 59. Flooring questionable. No curtain/or tracks installed; no privacy. *Military Medicine, Treatment Room - Gold Team*

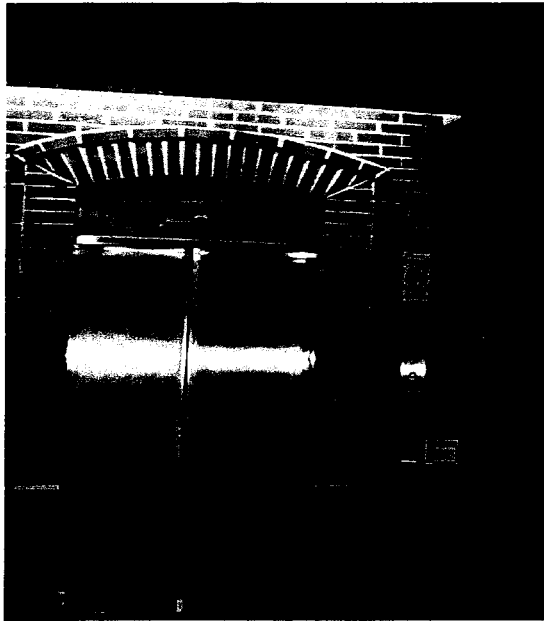
Picture 39

171. Interior Brickwork and detailing is excellent. *Interior, General – Green Team*

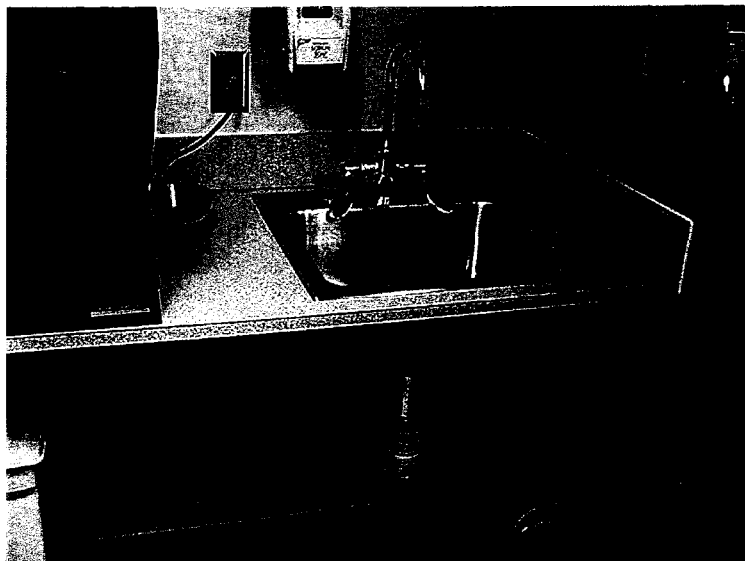
Picture 43

195. This room needs a cubicle curtain to provide privacy for patients in chair. *Laboratory, Blood Draw Room 1B06 - Blue Team*
196. Sink countertop--The current countertops have sharp corners and are open in the bottom, exposing the piping. Suggest insuring that future tables have rounded corners. In addition, suggest that the bottom be enclosed for cabinet, which would provide storage space and improve the appearance of the sink. *Pediatrics, Exam Room 1G19 - Gold Team*

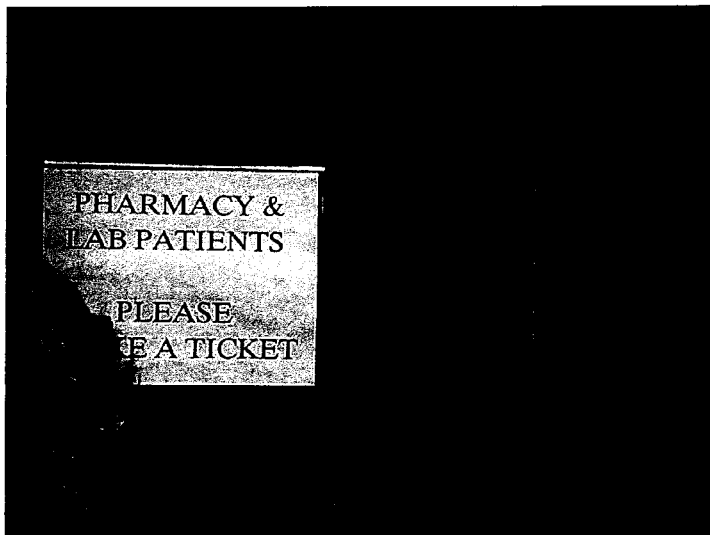
Picture 45

- 202. Room numbers confusing for patients, worked well for design (plans and specs) and for construction (areas A, B...E, H). *General, Signage - Blue Team*
- 203. General Signage Comment- Signs not flexible; need inserts. *General, Signage - Green Team*
- 204. Signs way too permanent with information shown and expensive to change. Signs should have clear window so information could be easily change by user. *General, Signage - Gold Team*
- 205. Signage not consistent. *Pharmacy - Green Team*
